**MARYLAND HISTORICAL TRUST  
DETERMINATION OF ELIGIBILITY FORM**

Property Name: Grove Farm Inventory Number: CE-28  
Address: 2125 Grove Neck Road Historic district: ☐ yes ☒ no  
City: Earleville Zip Code: 21919 County: Cecil  
USGS Quadrangle(s): Spesutie  
Property Owner: Maryland Department of Natural Resources Tax Account ID Number: 026828  
Tax Map Parcel Number(s): 9 Tax Map Number: 60  
Project: \_\_\_\_\_ Agency: Maryland Department of Natural Resources  
Agency Prepared By: Paula S. Reed & Associates  
Preparer's Name: Edie Wallace Date Prepared: 11/1/2010

CE-28, Grove Farm  
2125 Grove Neck Road  
Cecil Co., Maryland  
USGS Spesutie Quadrangle

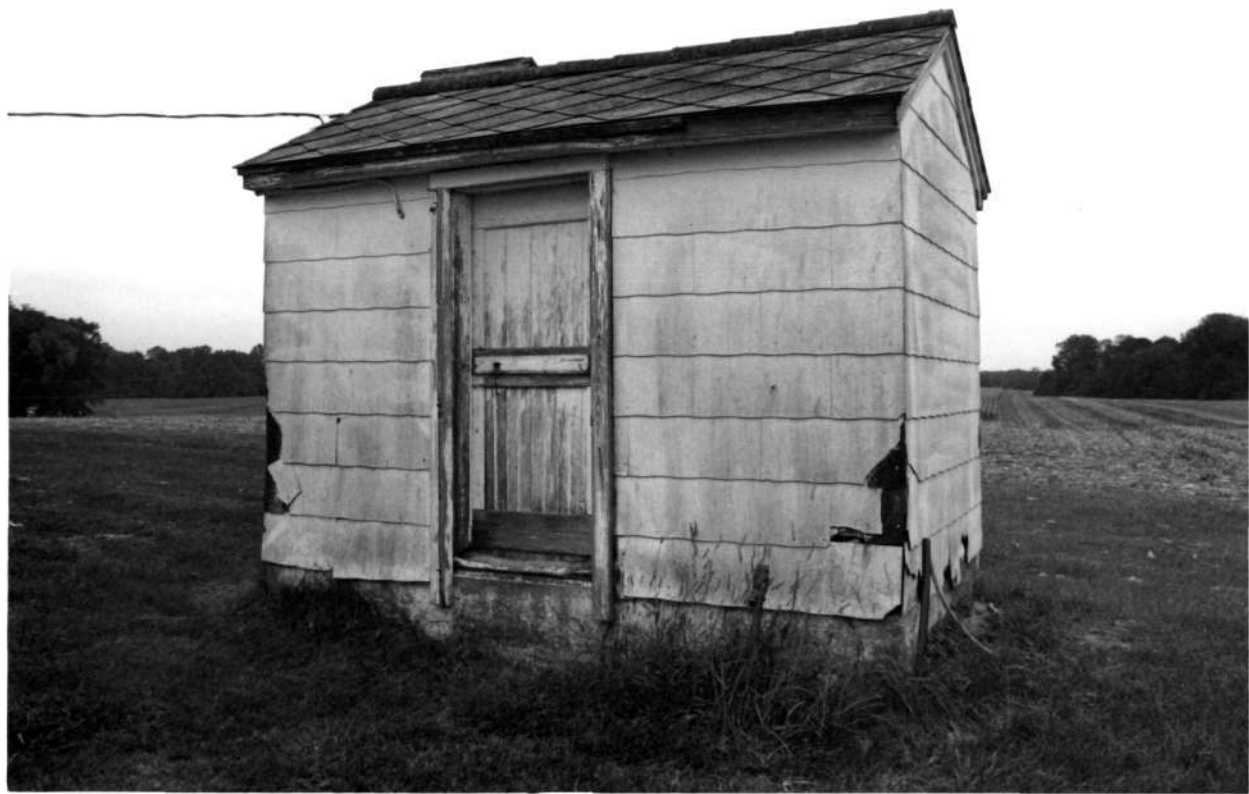
34/  
38

**Pump House:** Located immediately south of the Stone Foundation, it is a small frame building on concrete foundation. The walls and roof are covered with asbestos shingles. The interior walls are covered with tongue-in-groove wood panels. The pump apparatus remains intact. Just southeast of the pump house is the concrete foundation for the windmill (shown in the 1978 photos MIHP #CE-28). Some of the apparatus remains in place.

Pump House, east and north elevations, view SW

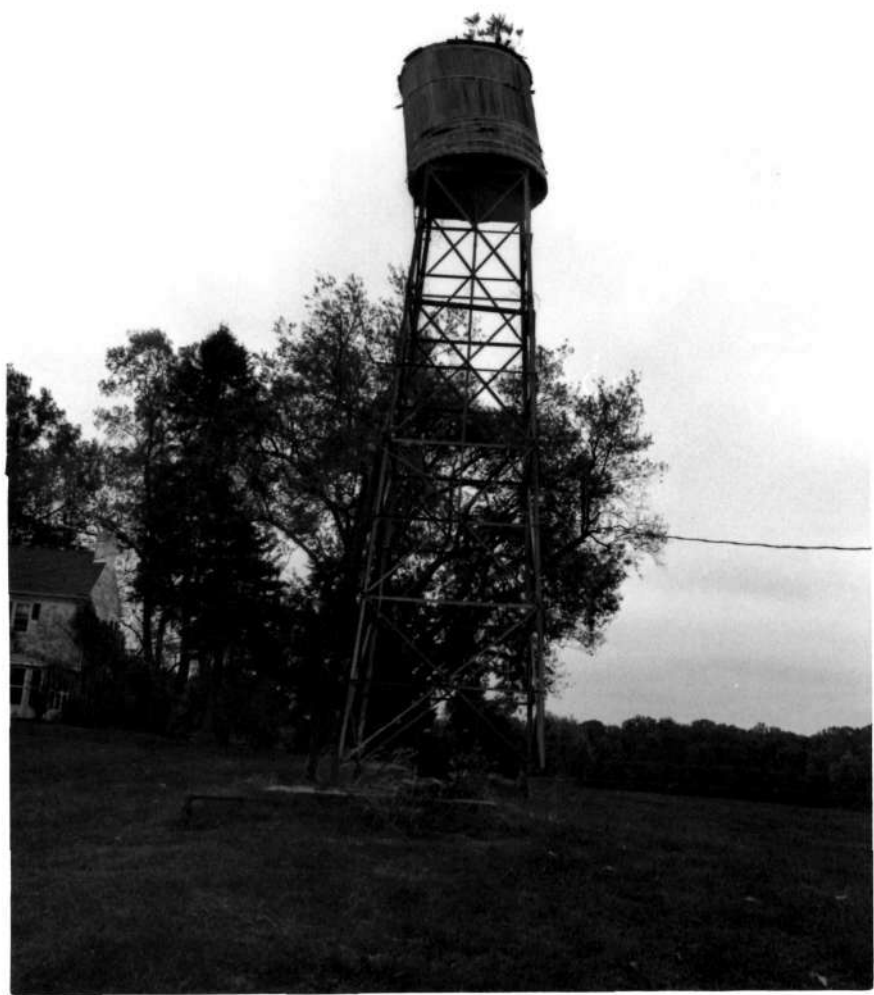
35/  
38

**Water Tower:** Just south of the windmill remnant stands the wood stave water reservoir on a metal frame tower.

Water Tower, view S

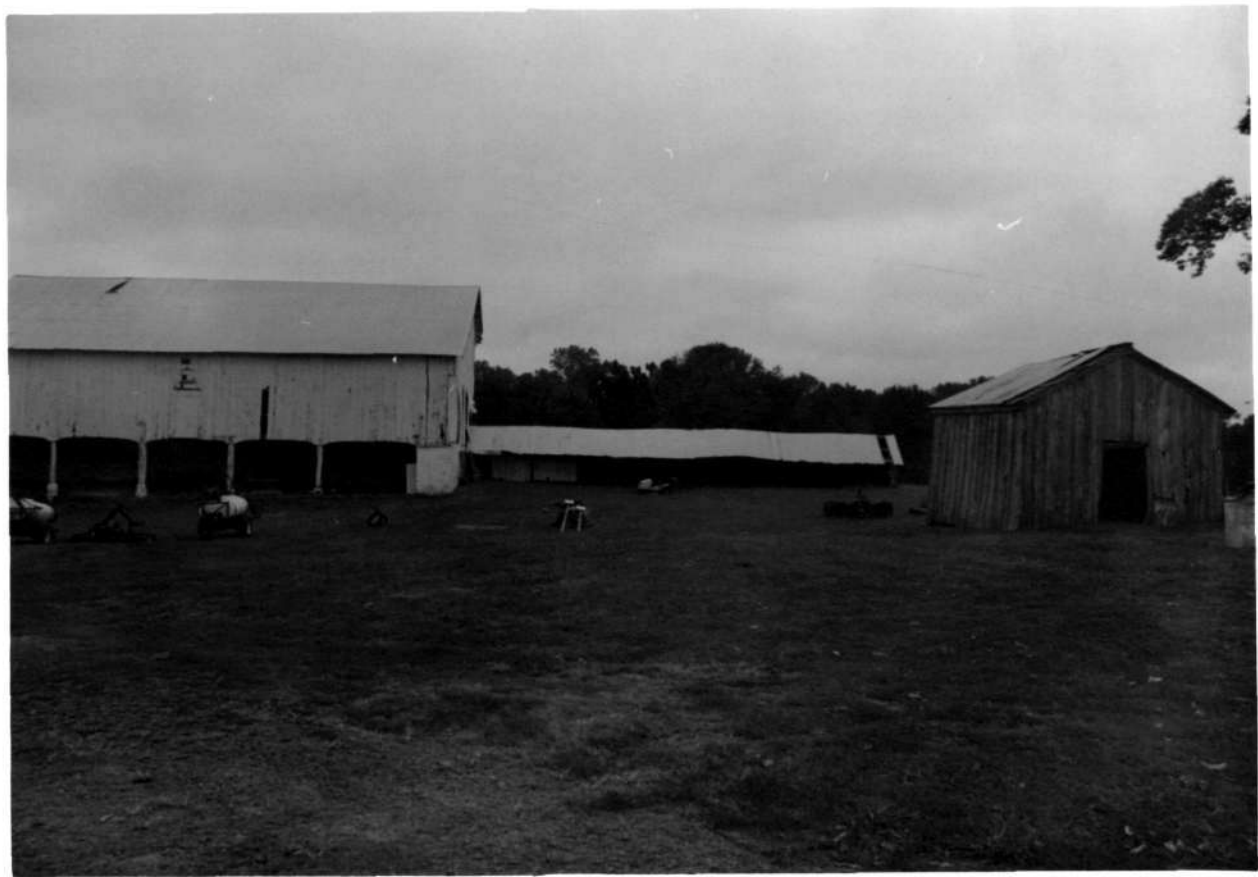
36/  
38

**Wooden Shed:** Standing northeast of the Wagon Shed/Corn Crib is a small wooden shed of unknown use. The frame construction is gable-front with a center door. It is covered with vertical board and batten siding. The wood shingle roof is covered with a deteriorating metal roof. This building is in very poor condition.

Bank Barn, south elevation, view NE showing attached  
equipment shed and Wooden Shed (right/east)

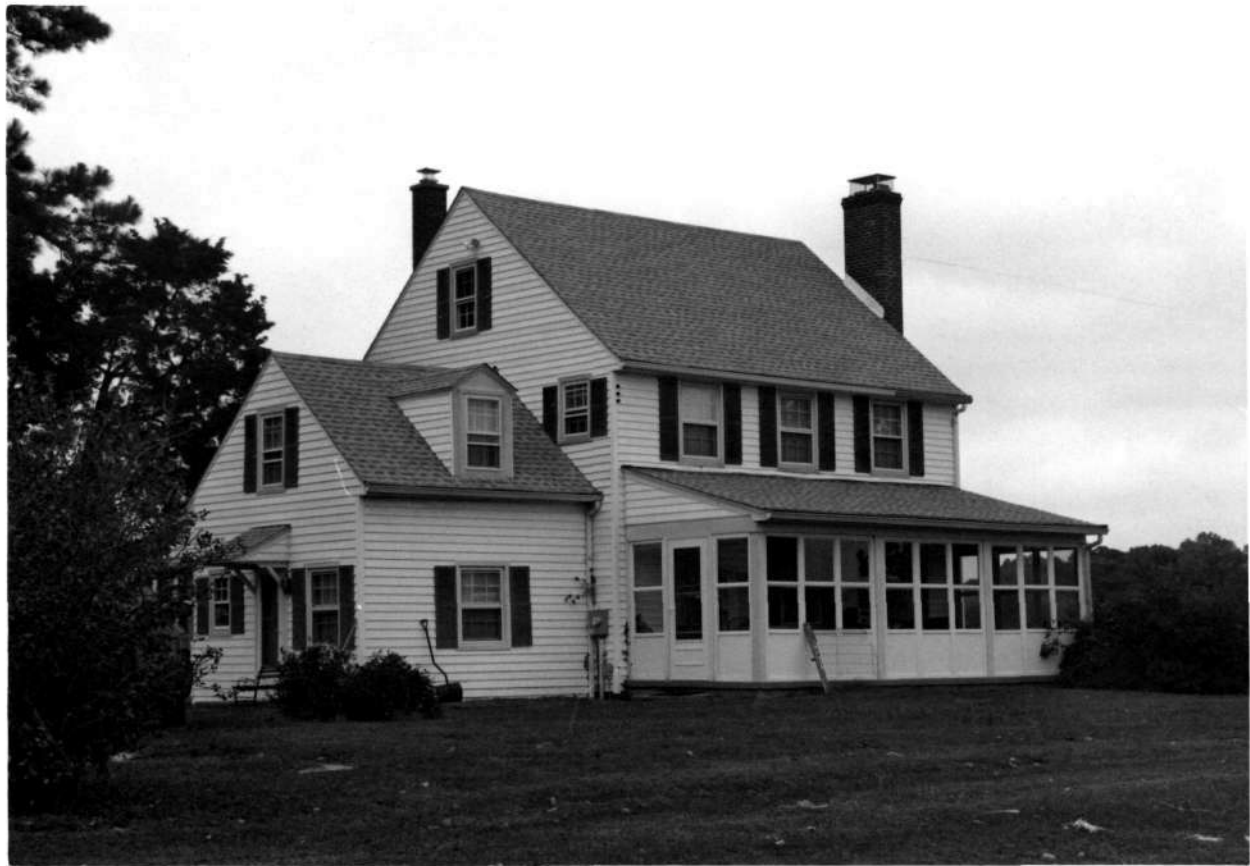
37/  
38

**Two-Story Tenant House:** On the east edge of the Grove Farm building complex standing northeast of the Wagon Shed, is a two-story, three bay frame tenant house, reportedly built in 1943. The house has 6 over 6 sash windows, vinyl siding and asphalt shingle roof. There is an enclosed front porch and several one story shed additions.

Two-story Tenant House, west and south elevations, view NE
